# Deflections and failure modes in dry-stone retaining walls

by M.R. COOPER\*, BSc, MSc, DIC, MICE, CEng

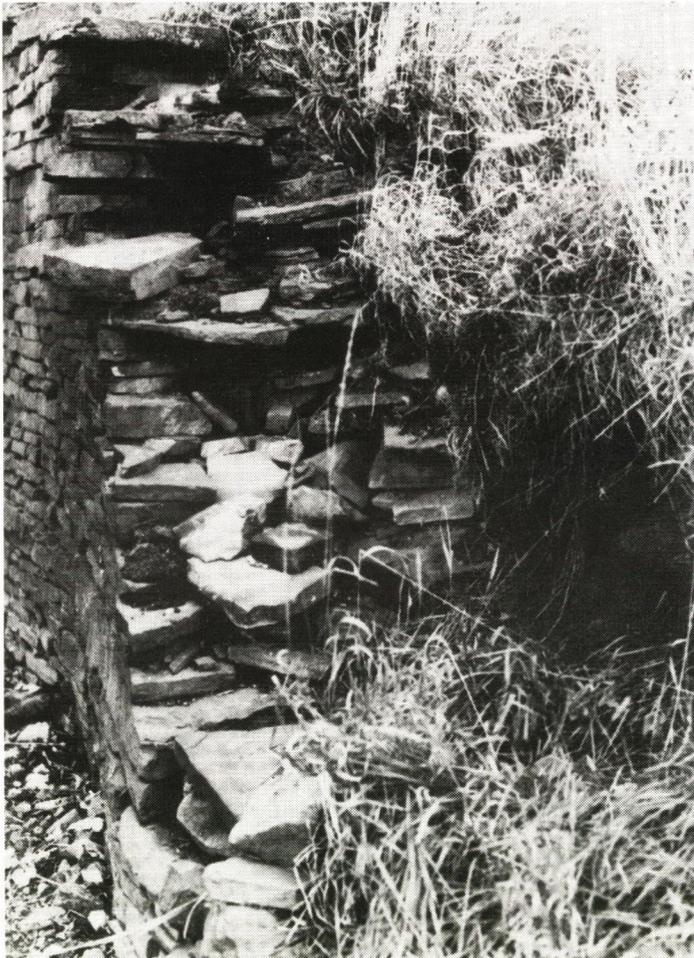
Fig. 1. Typical wall construction

At present there is little information on the compressibility parameters applicable to dry-stone walls and Figs. 5(b) and 7 have been produced using presumed angular compressibilities of  $0.2\%/kN.m$  for the boundaries between  $0.6m \times 0.4m$  wall elements. This angular compressibility is undoubtedly excessive for perfectly plane faces of fresh stone but is thought to represent fairly well the conditions in real walls of the form shown in Fig. 1.

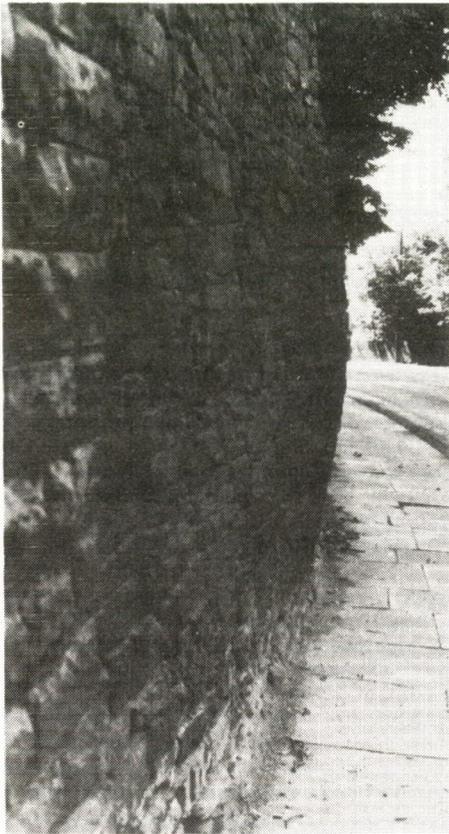
Fig. 6. Example of bulging on a rigid base — note decay of wall at base

Bulging failures on truly rigid bases appear to be comparatively rare, except where accelerated weathering of the lower part of the face has increased the compressibility dramatically in the zone of negative eccentricity. Such a case is shown in Fig. 6, where the extent of the deterioration is evident in the foreground.

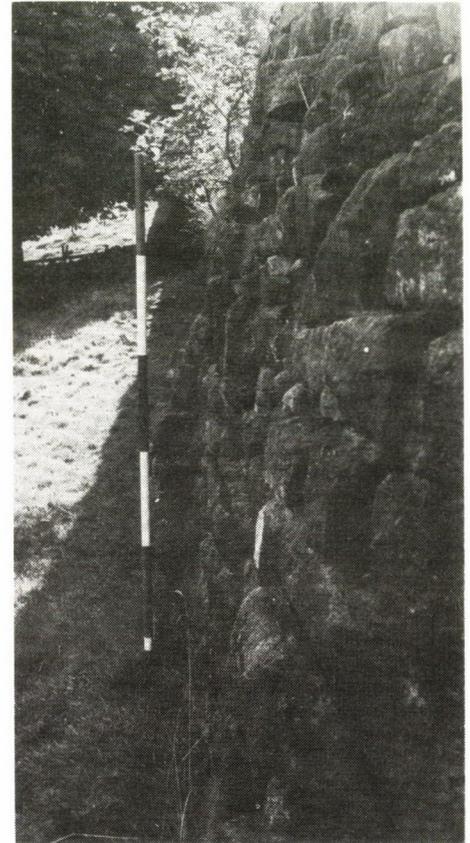
Inadequate bearing capacity of the wall foundations is most likely to give rise to a bulged profile in the distressed wall. Ticof (1978) demonstrated that an eccentric vertical load on a footing will produce a bearing capacity failure emanating from the side favoured by the eccentricity. For a retaining wall this effect is magnified by the inclination of the resultant thrust on the base, and by the greater depth of the base with respect to the retained side. The resulting mechanism involves appreciable forward movement and rotation of the base, with a smaller downward movement concentrated at the front of the base as sketched in Fig. 8. This combination of base rotation and forward movement is typical of many retaining walls with pronounced bulges. Fig. 9 shows an example.

Fig. 9. Example of bulging due to inadequate bearing capacity

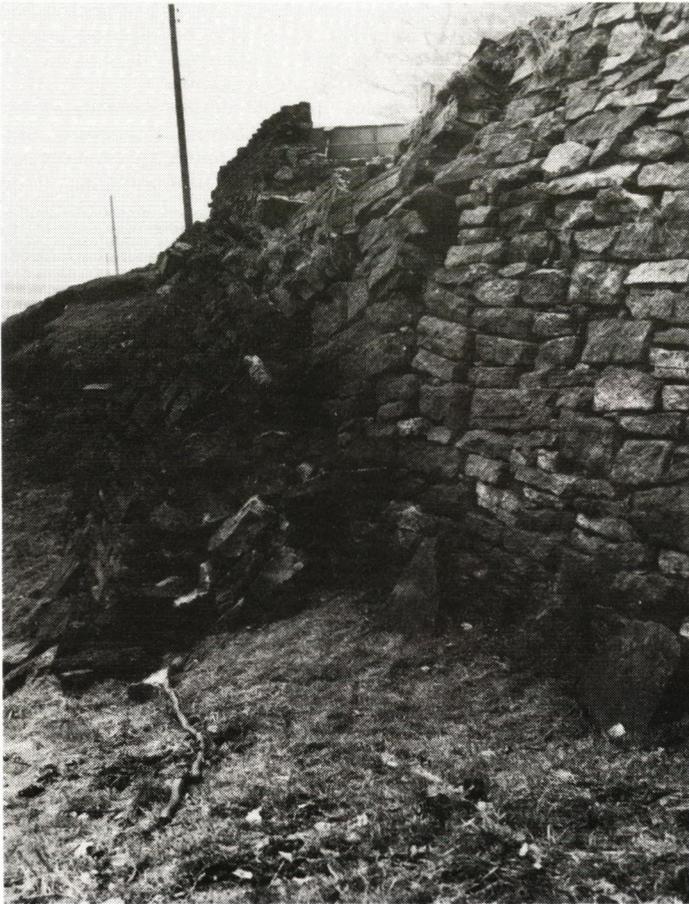
Failures involving relative sliding of the wall components appear to occur in one of two forms. In the most common case the active thrust is increasing more rapidly with depth than is the shearing resistance of the wall fabric and sliding is produced near the base. Complete sliding at the wall base is analogous to sliding of a rigid wall and differs only in post-failure appearance where the structure is usually badly disrupted. The results of a base sliding failure, instigated by slope instability below the wall are shown in Fig. 10.

Fig. 10. Example of sliding on base, due to instability below wall

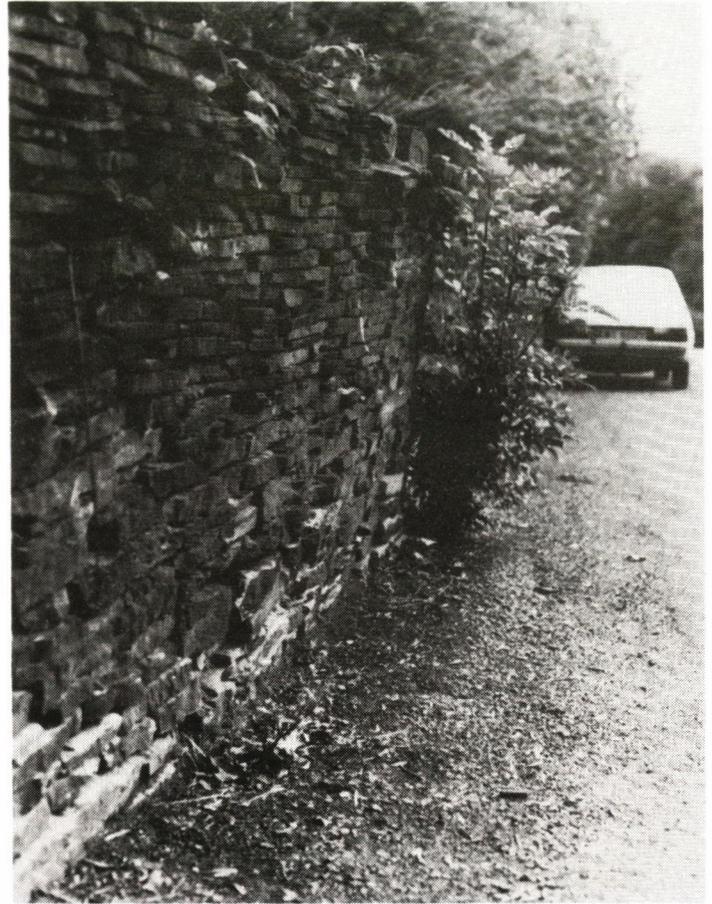
Here the softening and creeping of the near surface soils exerts an abnormally high thrust on the top parts of the wall. The result is a pushing forward of the top few elements as shown in Fig. 11.

Fig. 11. Example of distributed sliding in wall retaining sloping ground

Distributed relative sliding to give a concave front profile is a feature of the post sections of walls supporting sloping ground.
